Post-test Inspection of NASA's Evolutionary Xenon Thruster Long-Duration Test Hardware: Discharge Chamber

Rohit Shastry and George C. Soulas

Presented at the 52nd AIAA/SAE/ASEE Joint Propulsion Conference

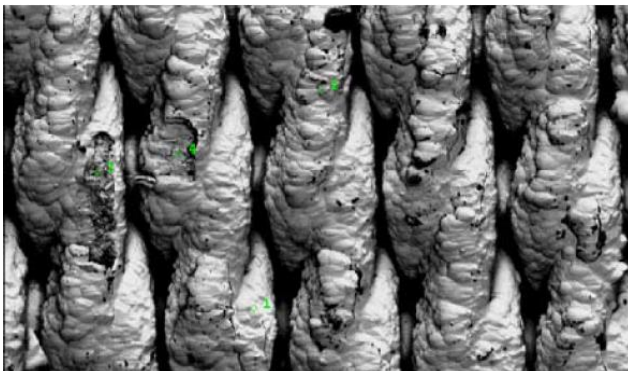
From NEXT LDT

- Discharge chamber mesh samples were removed at various axial locations and a fixed azimuthal location (axisymmetry of deposition assumed)
- Deposition coating evident in photomicrographs of mesh
- Energy dispersive x-ray spectroscopy indicates this coating is primarily grid material, although numerous nodules within mesh had high carbon content
- Similar results were found in NSTAR ELT

- Deposition on discharge chamber mesh is $\sim 15 \mu\text{m}$, much less than the estimated maximum retainable thickness
 - Large amount of flakes found at bottom of discharge chamber, including certain large ones that had spalled from accelerator grid apertures

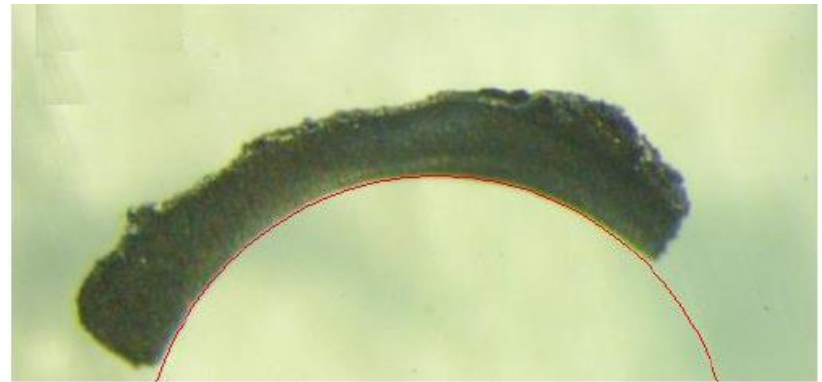
From NEXT LDT

- A large number of flakes were found at the bottom of the discharge chamber
 - Similar result to NSTAR ELT
- Numerous samples were taken, and a total of ~ 3.1 grams of material was collected from the discharge chamber
- Many of the largest flakes exhibited a semi-circular shape
 - Radius of curvature of these flakes indicate they had come from the accelerator grid apertures – similar result to NSTAR ELT
- Flakes were comprised of a combination of grid material and carbon

- Samples of flakes from different axial locations were analyzed to determine size distributions
 - Need to quantify likelihood of forming flakes large enough to short grids
- Histograms indicate that 99% of flakes have a largest dimension $< 200 \mu\text{m}$
- However, flakes do exist that are large enough to cause a grid-to-grid short
- NSTAR ELT also found large flakes, but determined that these flakes originated from the facility so should not be an issue in flight
 - Similar analysis on large flakes for NEXT LDT is presently underway

- Size distributions of flakes indicate that 99% have largest dimensions less than $200 \mu\text{m}$, much smaller than the grid gap
 - All insulators and electrical wiring inspected with no signs of arcing found
